National Register of Historic Places
Registration Form

historic name Routzahn-Miller Farmstead

other names F-4-141

street & number 9117 Frostown Road

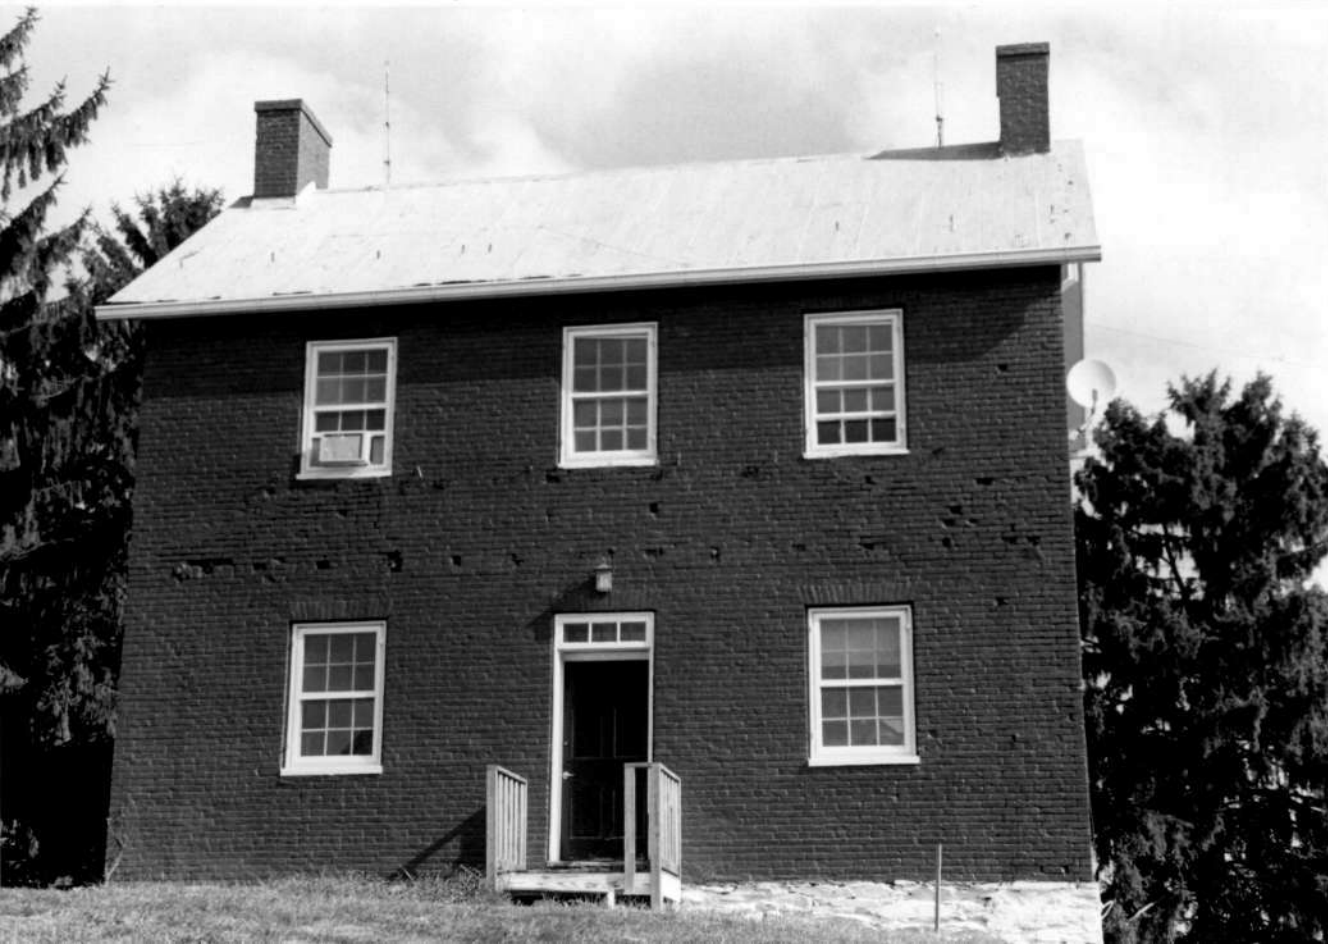
4/
21

Main house, SW elevation, view NE

Main House: The main house is a brick, two-story, three-bay gable end structure on a limestone foundation. A double-flue brick chimney rises from the interior of each gable end. The front (southwest) elevation sits perpendicular to the hillside, so that the southeast (downhill side) elevation foundation is exposed with walk-in access to the cellar. The front elevation brick is laid in a 5:1 common bond pattern (5 rows of stretchers to 1 row of headers) with flared standing brick jack arches above the window and door openings. The windows are relatively small, with 6-over-6 double-hung sash. There is a three-light transom above the central entrance, however there is a four-light transom immediately behind the three-light transom. The door is six-panel. A stepped brick corbel lines the cornice below the eave. A full-length porch was removed leaving a ghost of the roofline in the bricks; this was probably a later addition to the original

façade. The overall impression is a symmetrical and refined vernacular farmhouse with Federal style architectural influence, built ca.1825.

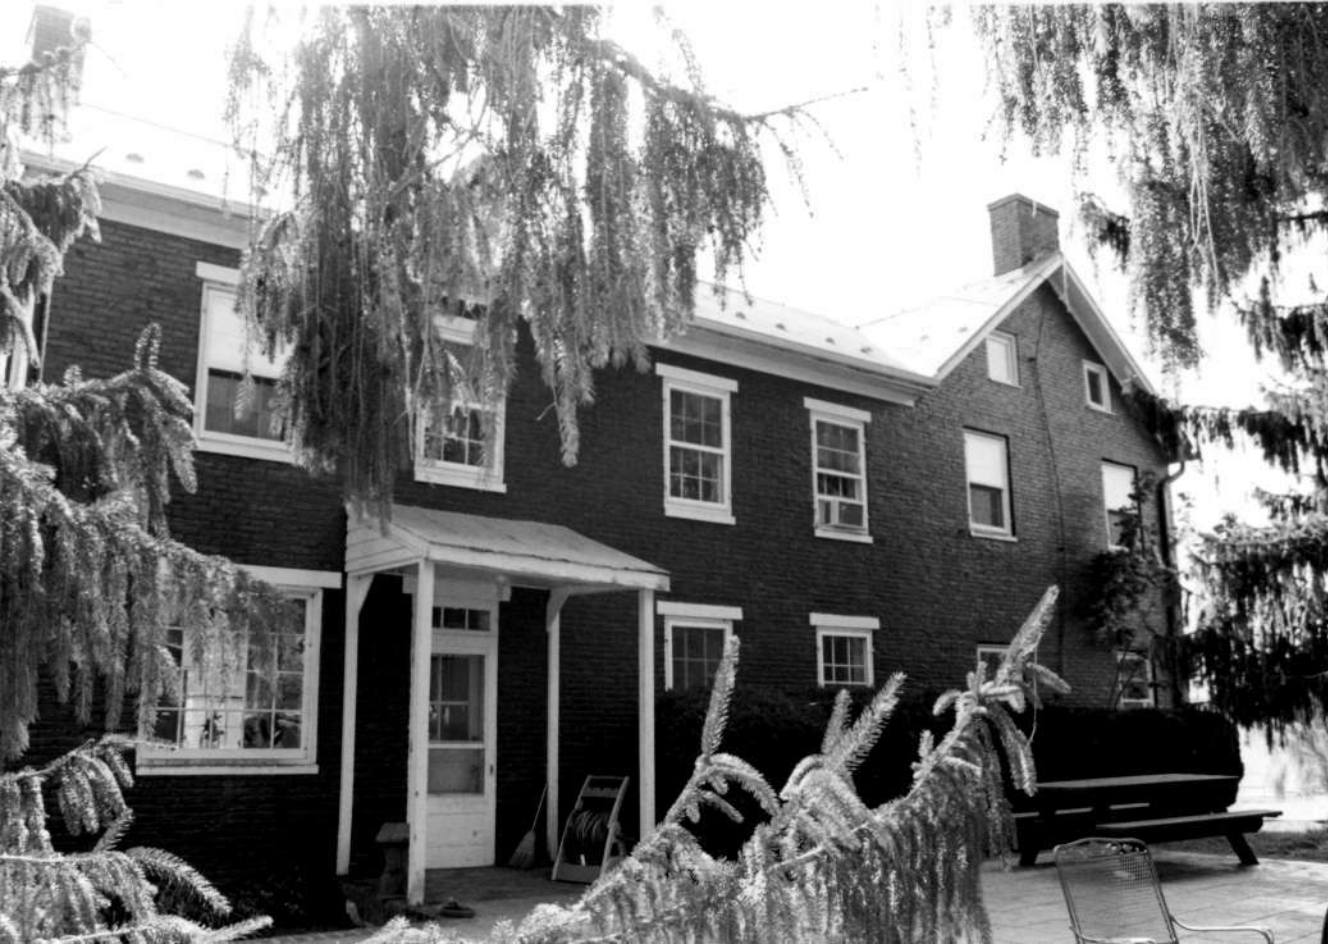
5/
21

Main house, NW elevation, view S

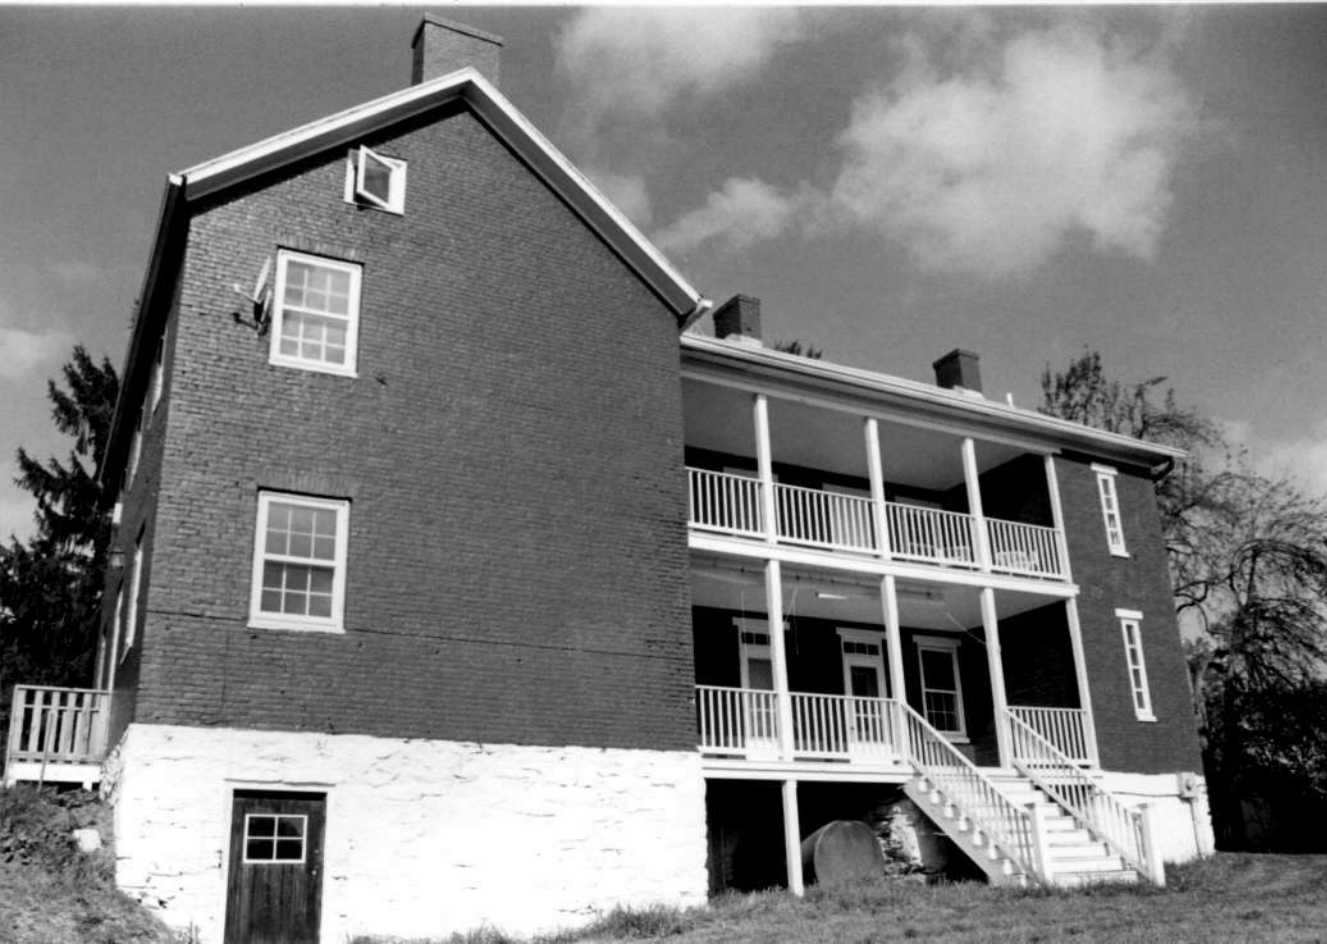
6/21

Main house, SE elevation, view N

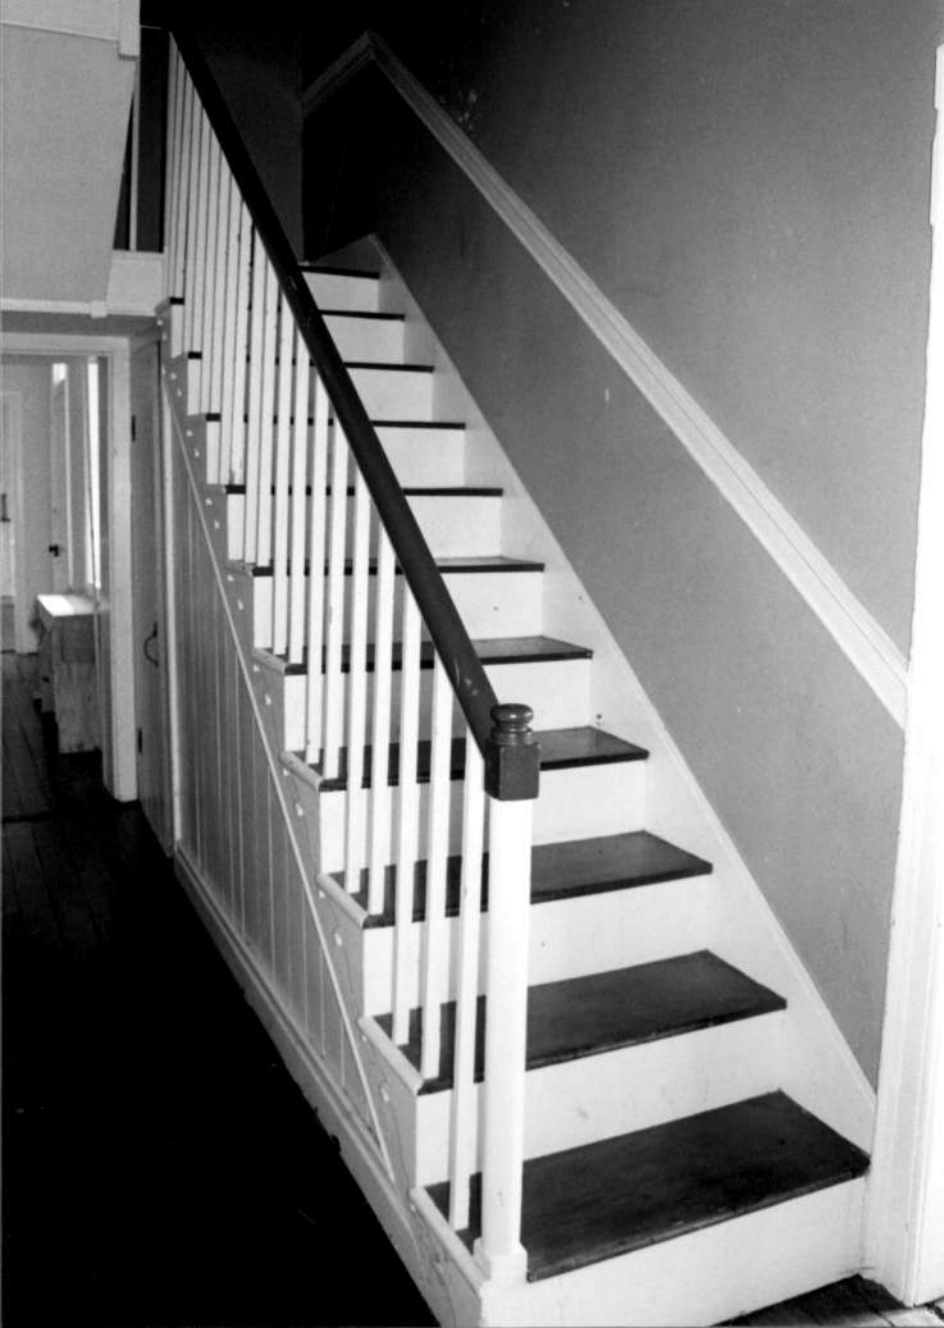
7/21

Main house interior, 1st floor, center hall stair
view NE

The interior of the house reveals a more transitional Federal/Greek Revival influence. It is laid out in a central passage and parlor plan. The hall has a door at both the southwest (front) and northeast (back) ends and stairs to the 2nd floor along the interior southeast wall. The handrail is rounded with a plain newel post. The stair spandrel has decorative "curl and drop" trim. A chair rail follows the stairs to the first landing. There is vertical beaded board panel below the stair spandrel and a closet. A beaded board nailer is located in the northeast interior wall beside the entrance. The east parlor has a Greek mantel with fluted pilasters. The west parlor has a Greek mantel with plain corner blocks. Window, door, chair rail and baseboard moldings throughout the front section of the house are trimmed with Grecian ogee molding. A six-panel grain painted door opens between the west parlor and the ell addition.

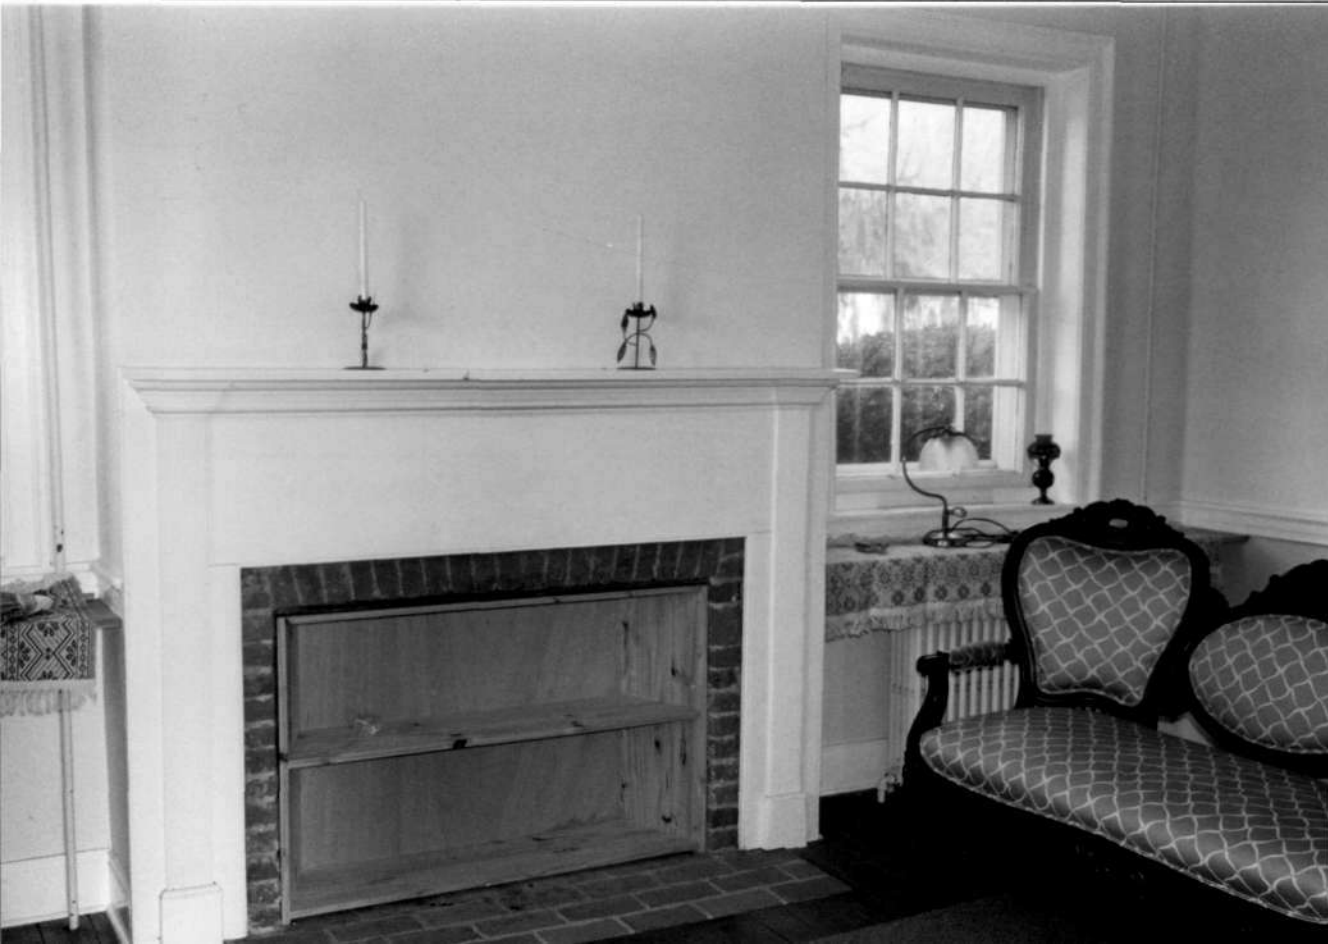
8/21

Main house, interior, 1st floor, SW parlor

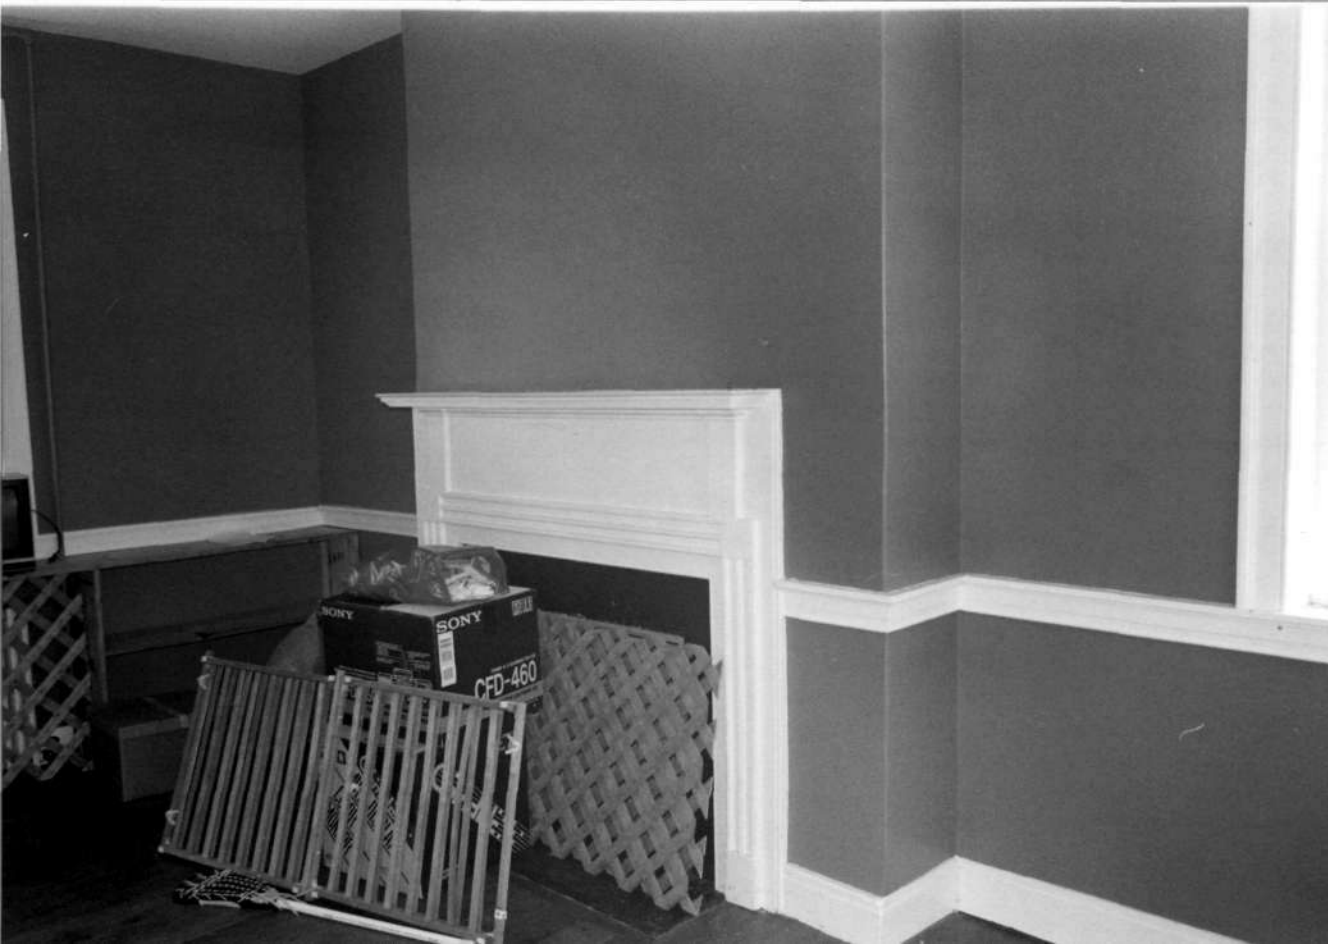
9/21

Main house, interior, 1st floor, SE parlor

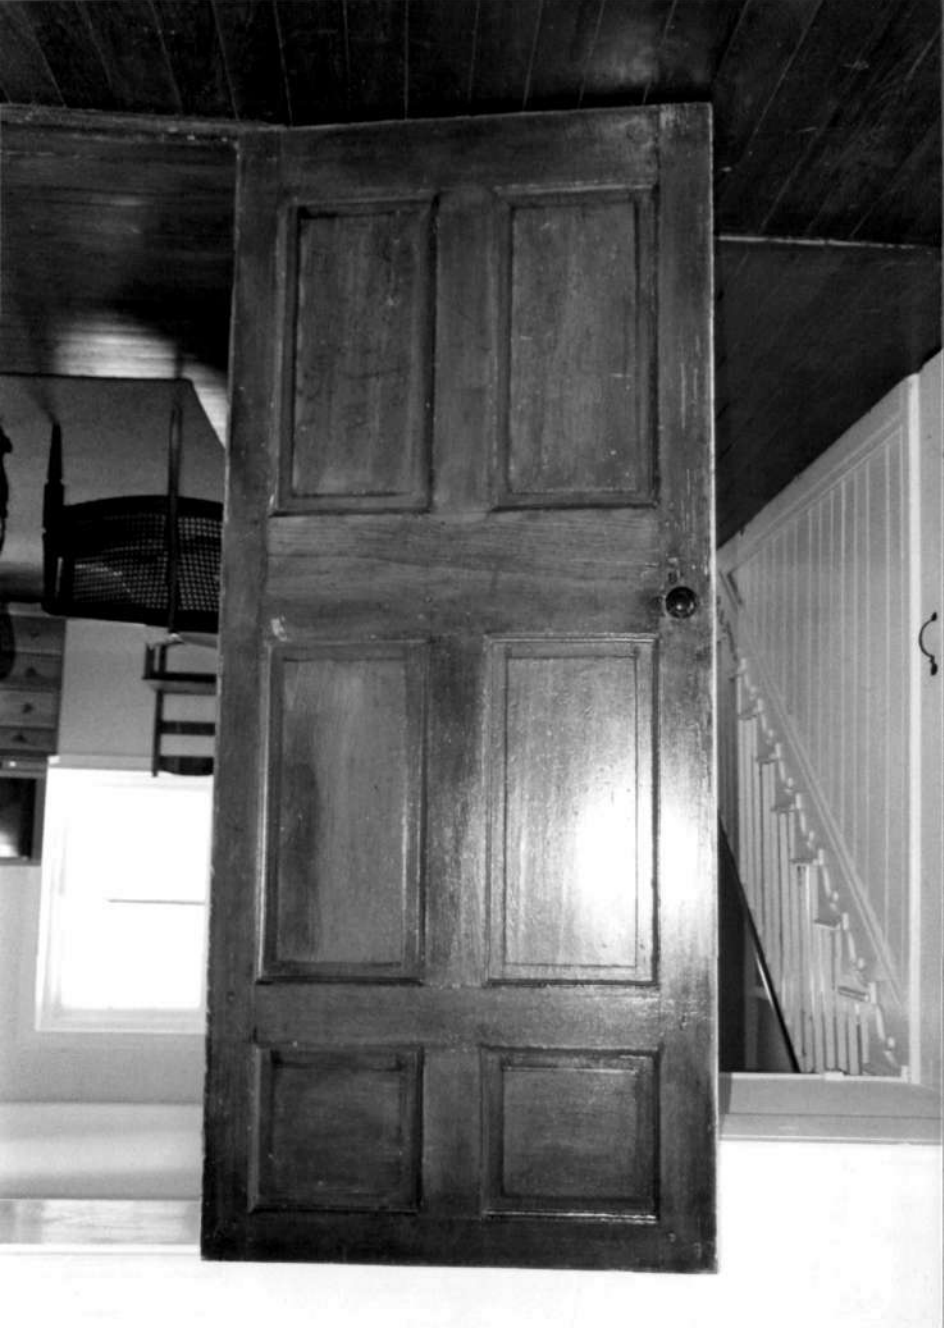
10/
21

Main house interior, 1st floor, view SW from dining
room in ell toward center hall + SW parlor

The ell addition includes a dining room and kitchen, both with access to the recessed porch on the northeast. The interior wall between the two rooms includes a fireplace for the dining room and an enclosed stair to the 2nd floor and to the cellar. All doors within the ell are four-panel and all transoms are three-light. There is no chair rail in the ell. The kitchen was modernized within the last several years.

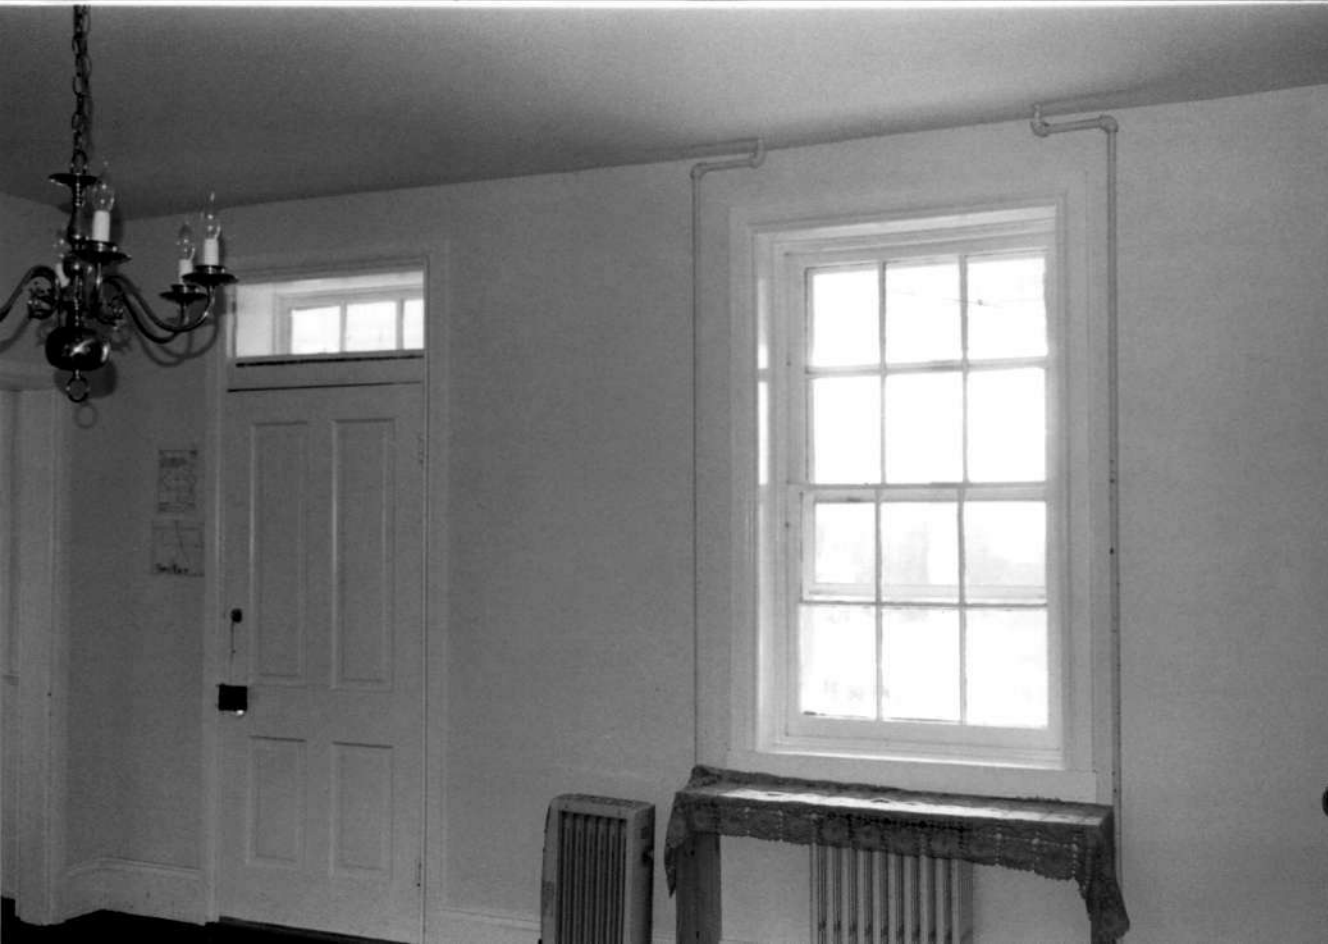
11
/ 21

Main house, interior 1st floor, dining room, view NE

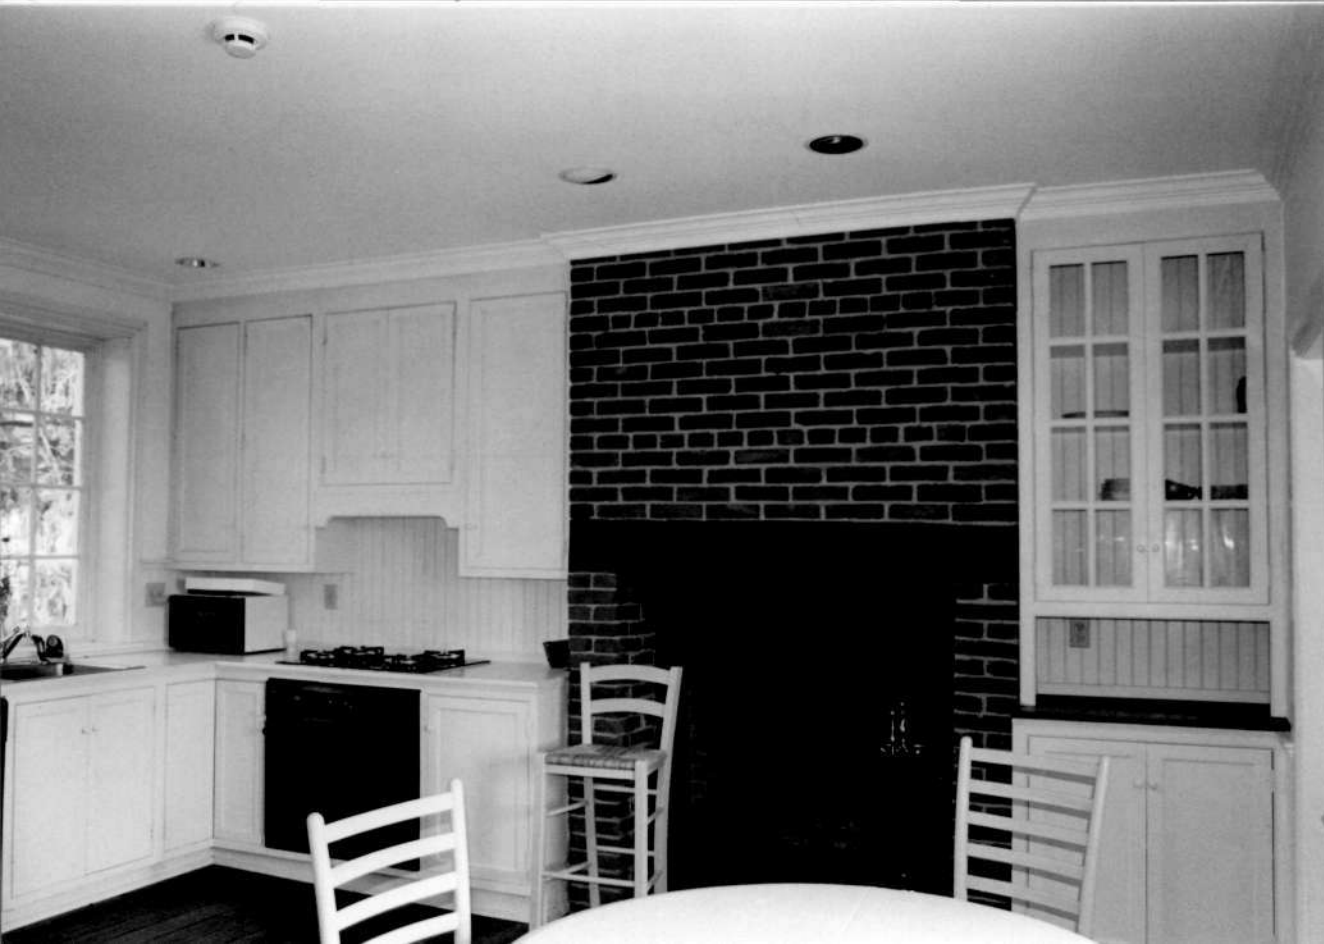
12/
21

Main house, interior 1st floor, kitchen, view toward
NE end wall

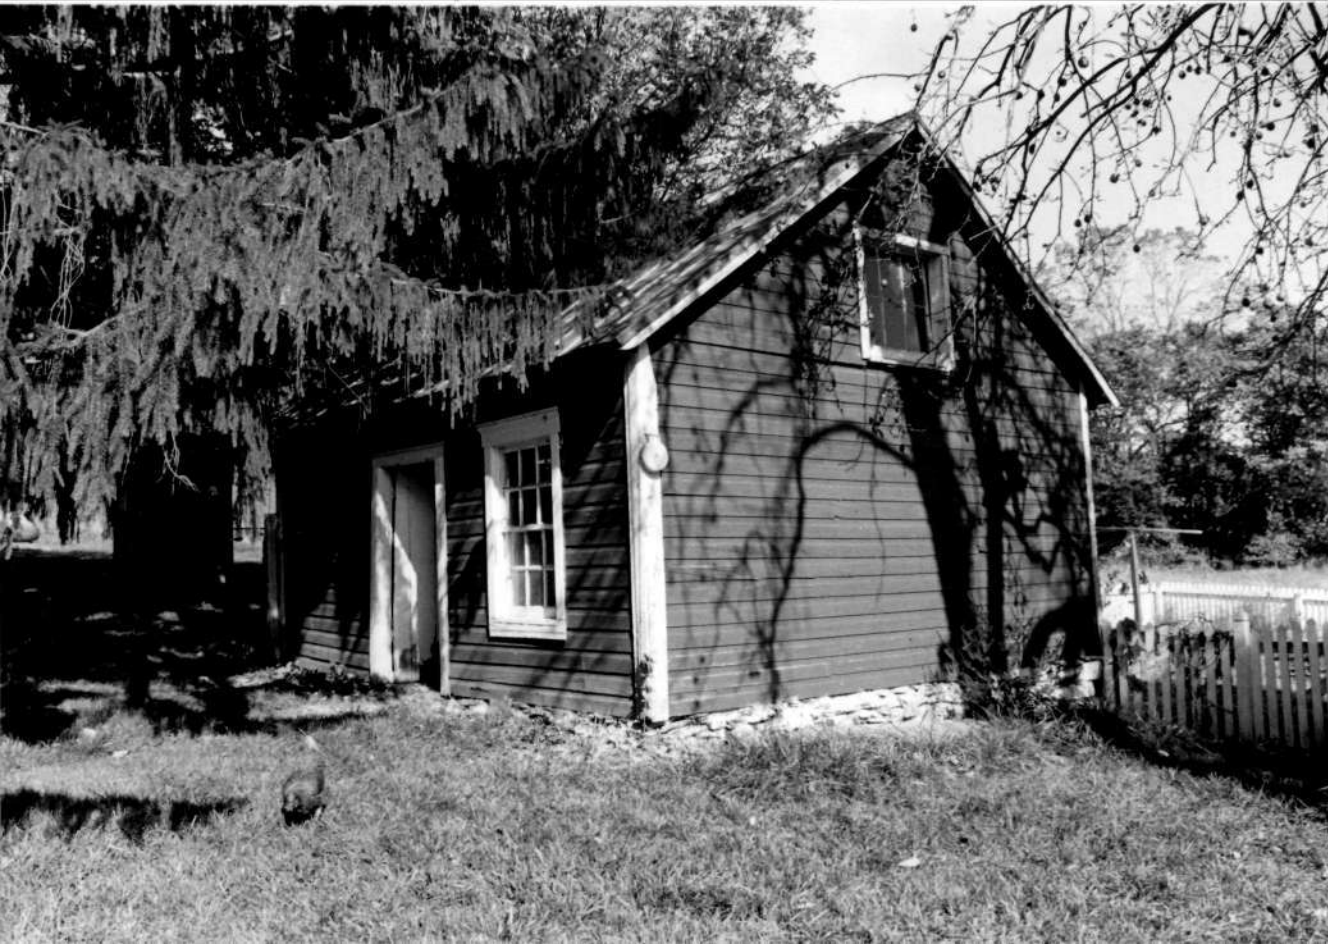
13
21

Out-kitchen/washhouse, view N

Out-kitchen/Washhouse: The building is a gable end, 1-story frame construction with unfinished walls on the interior. The large fireplace in the northwest wall is stone with a heavy timber lintel. The floor is concrete. There is a loft space accessed by a frame ladder and lit by a fixed six-light window in the gable end. The exterior walls are covered with wood German siding. The windows are 6-over-6 sash with a shelf trim above. The door is vertical board and batten.

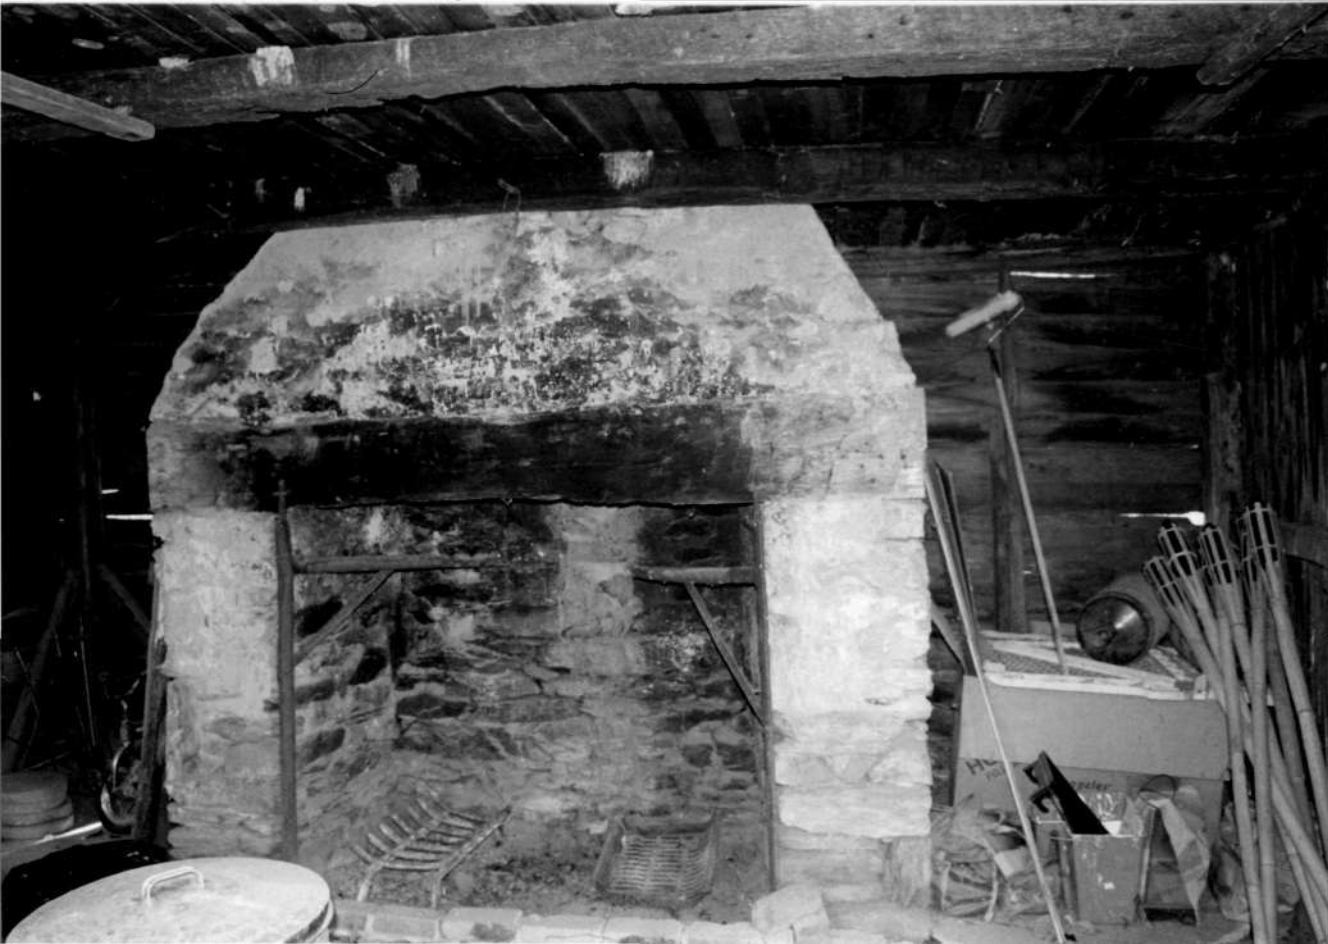
14
/ 21

Out-kitchen/washhouse interior, view toward
NW wall

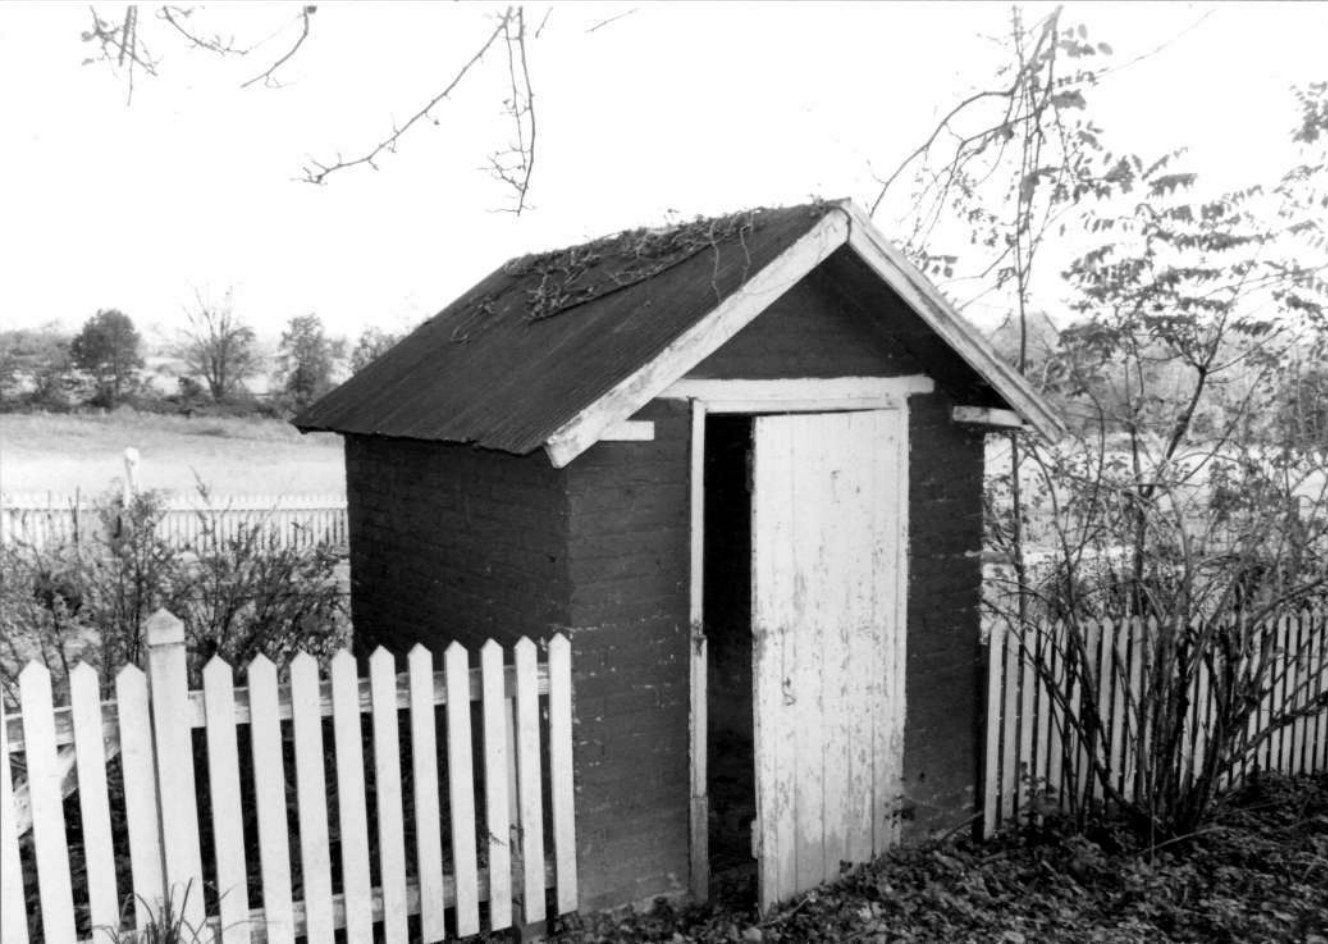
15
/ 21

Smokehouse, view E

Smokehouse: Constructed of brick, the smokehouse has a gable front. The vertical board and batten door has a narrow wood lintel. The interior is plastered with exposed rafters. The roof is covered with corrugated metal sheets.

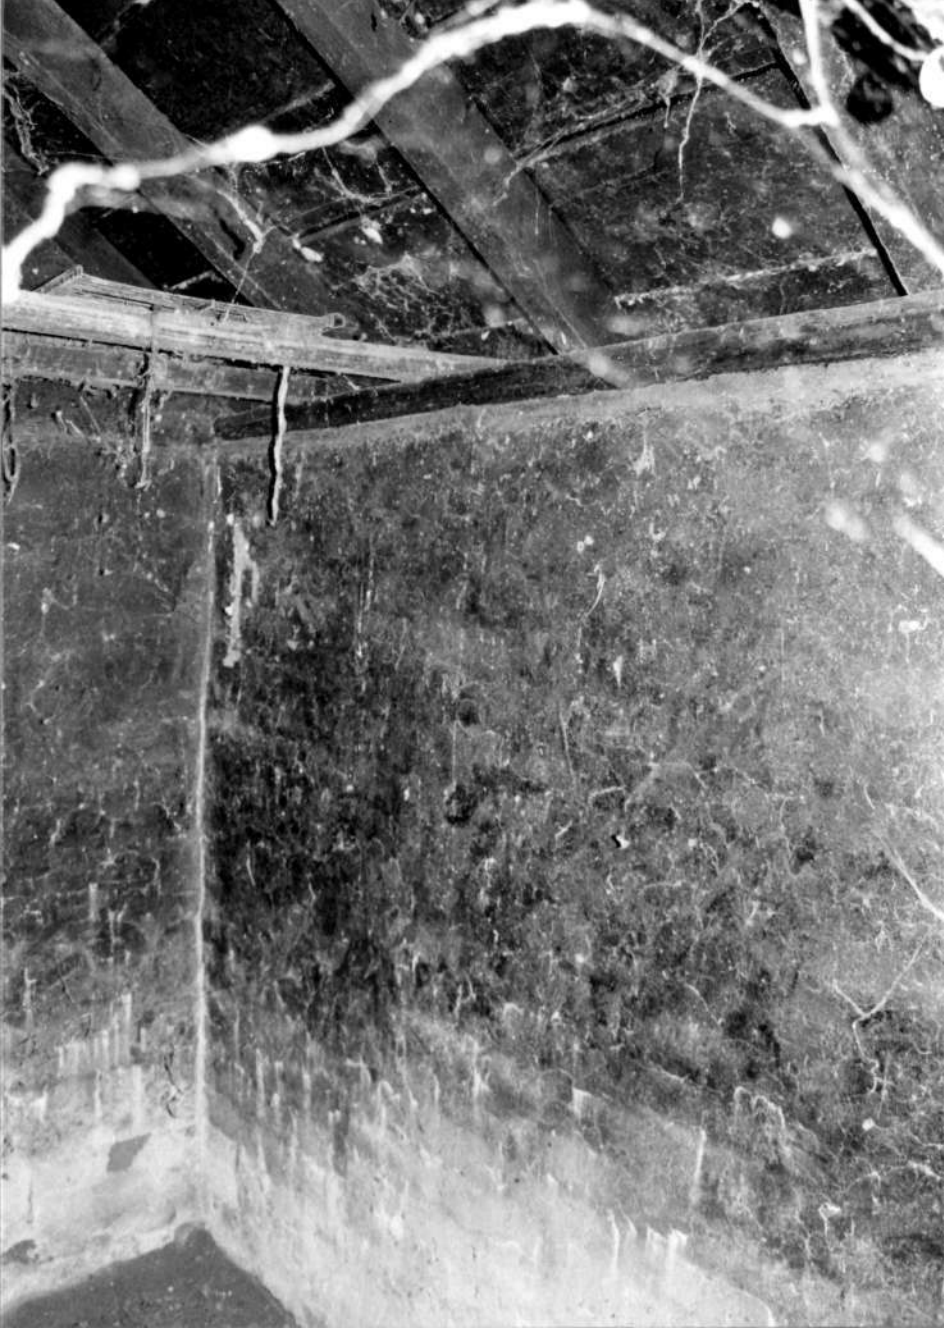
16/21

Smokehouse interior, view E

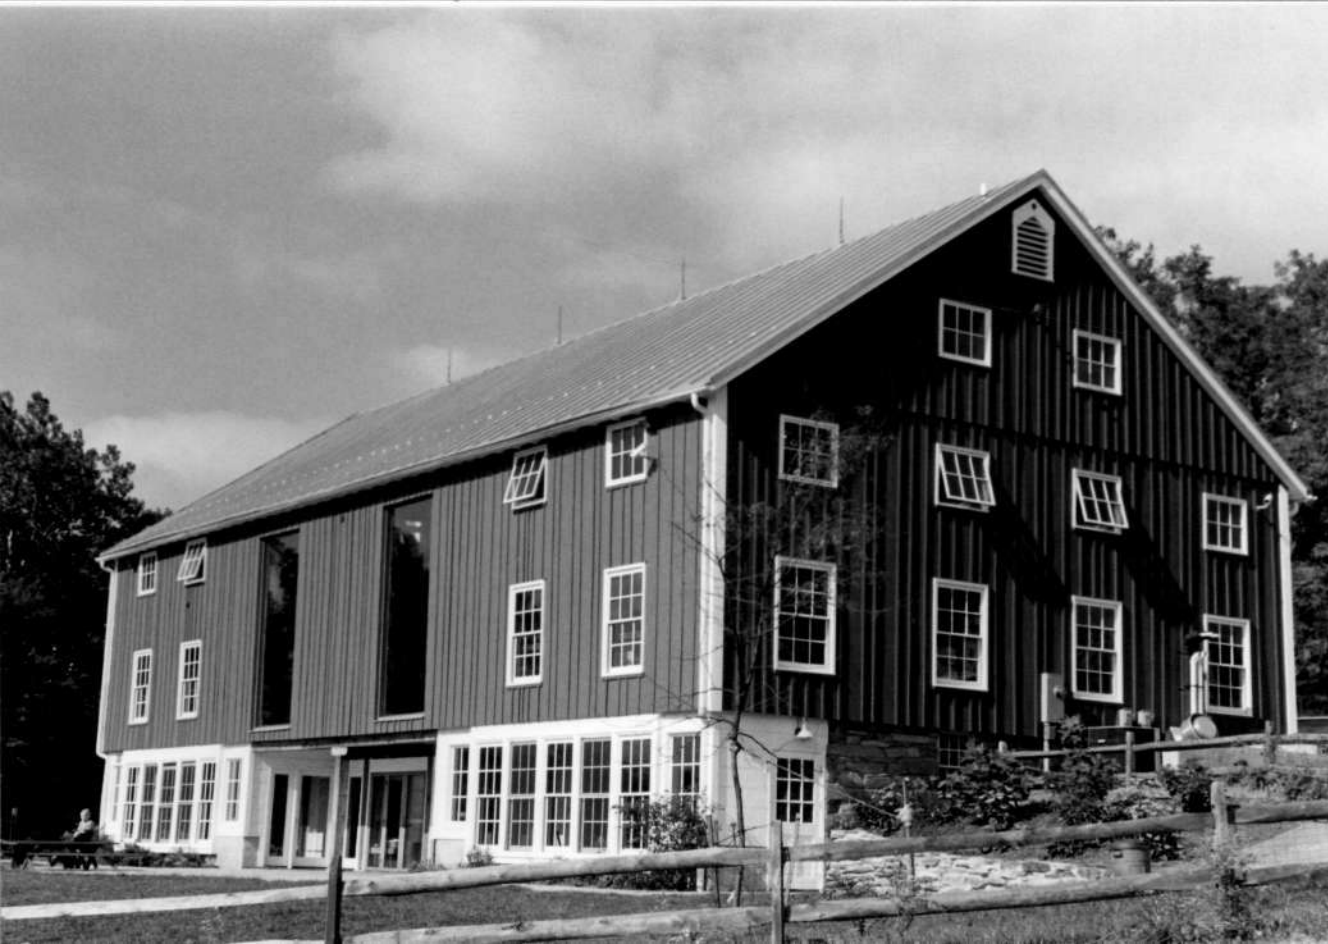
17
/ 21

Bank barn / pre-school facility, view NW

Bank Barn: The timber frame Pennsylvania style bank barn was rehabilitated for use as a Pre-School in 2002. The building's structural timber framing remains intact as does its limestone foundation. The shape and size of the barn was not altered. New board and batten siding was applied with two levels of windows to provide interior light. The forebay was also enclosed with banks of 6-over-6 sash windows. The large sliding doors on the bank side were replaced with a bank of glass doors (required by code). The interior framing is exposed and much of the open space of the threshing floor remains open. Although this building would not be considered individually eligible for the National Register because of the relatively dramatic changes, it continues to contribute to the farmstead complex.

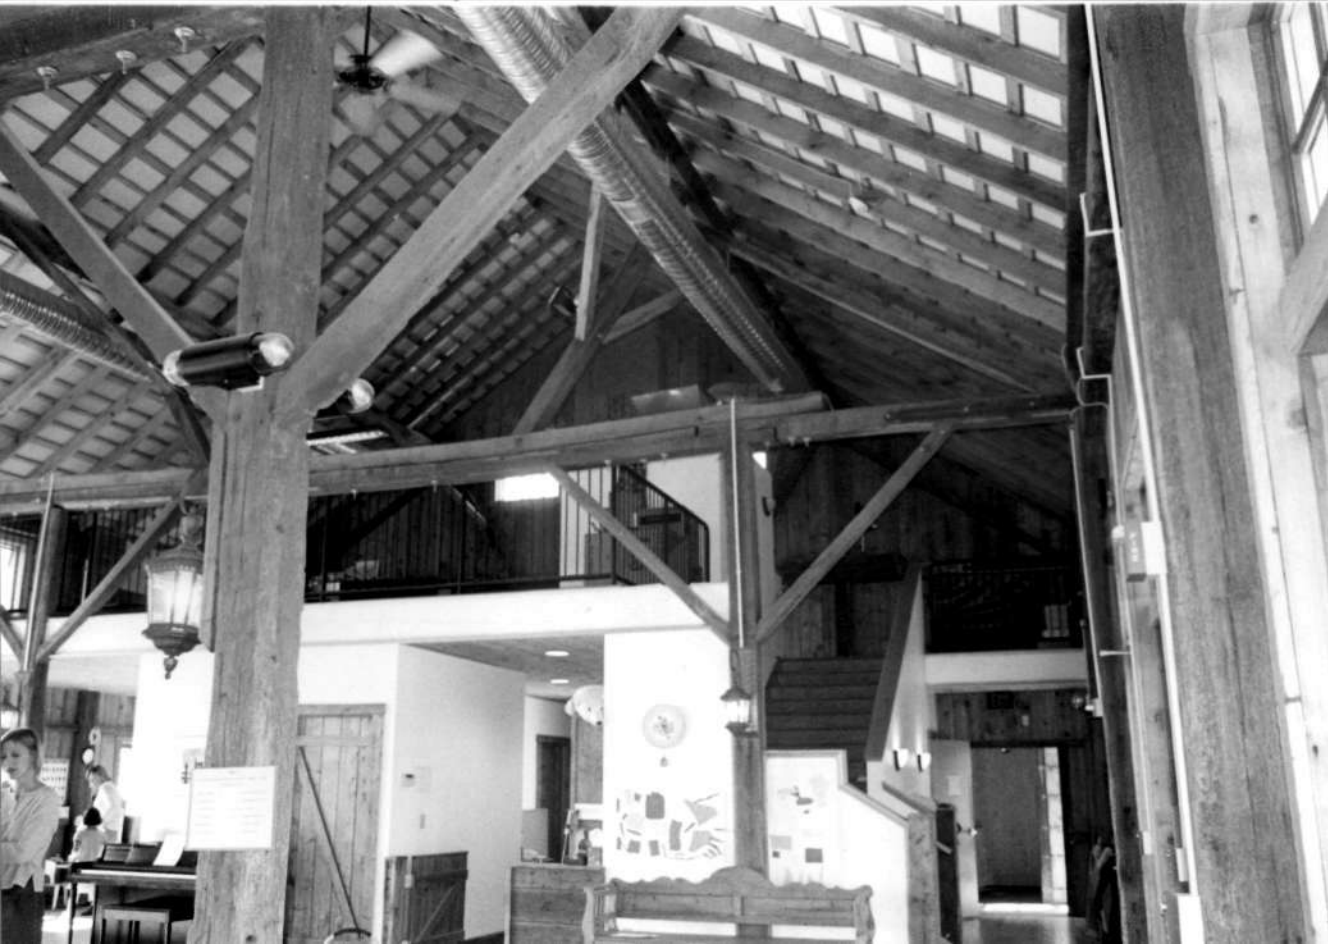
18
/ 21

Bank barn / Pre-school interior, view toward
SW wall

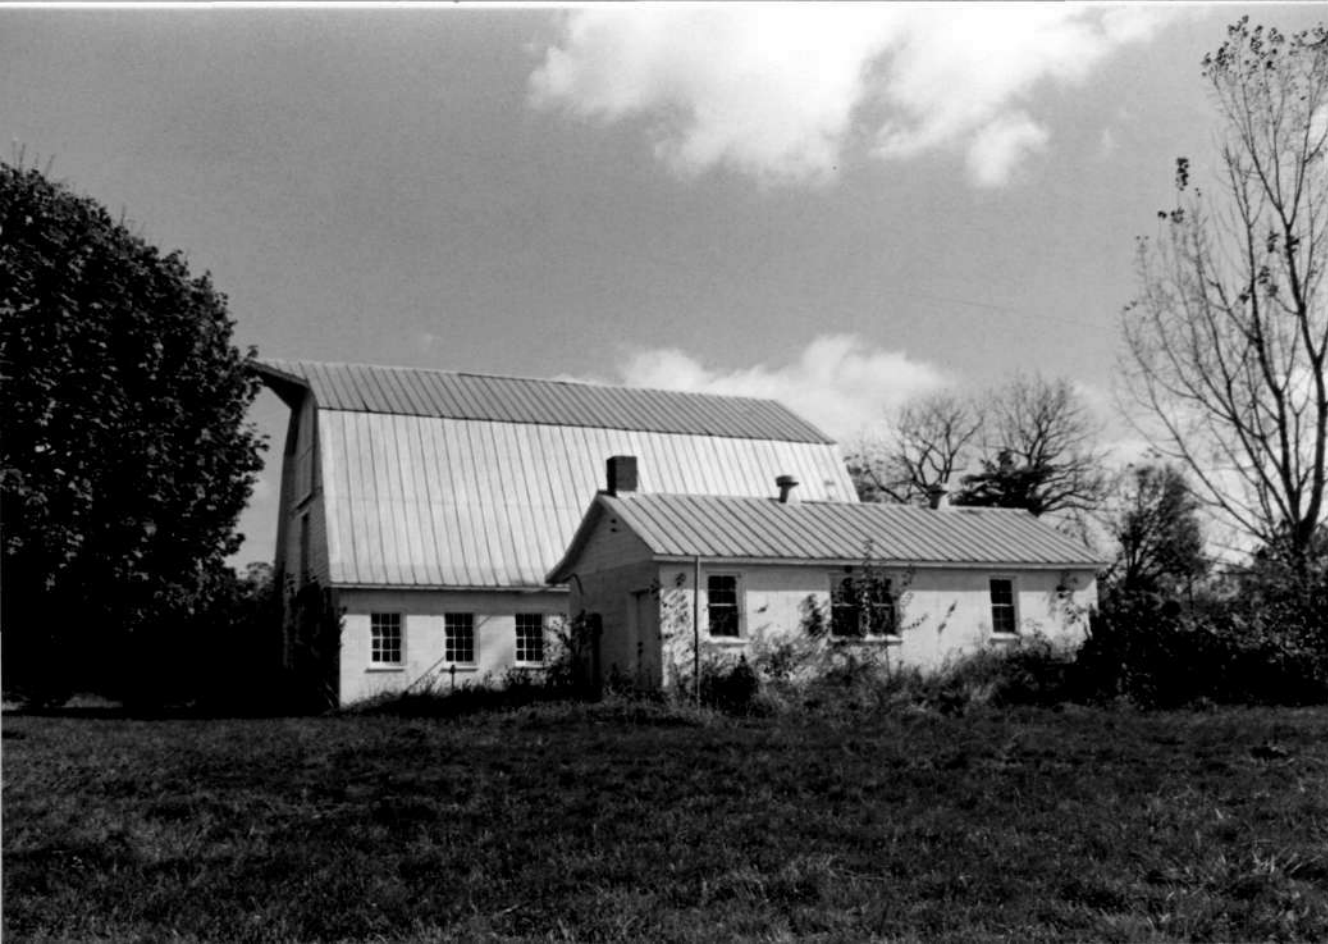
19
/ 21

Dairy barn and milk house, view E

Dairy Barn: The dairy barn is a concrete block structure with frame gambrel roof covered with metal sheets. It is 7 bays long with replacement 6-over-6 sash windows. The roof area includes two loft stories with board and batten doors and a hooded hayrack pulley on the northwest end. Gable ends are covered with wood German siding.

Milk House: The milk house is also constructed of concrete block, one story with a metal roof and two metal roof vents. It has a brick interior chimney in the northwest gable end. A roofed, open-sided breezeway connects the milk house with the dairy barn.

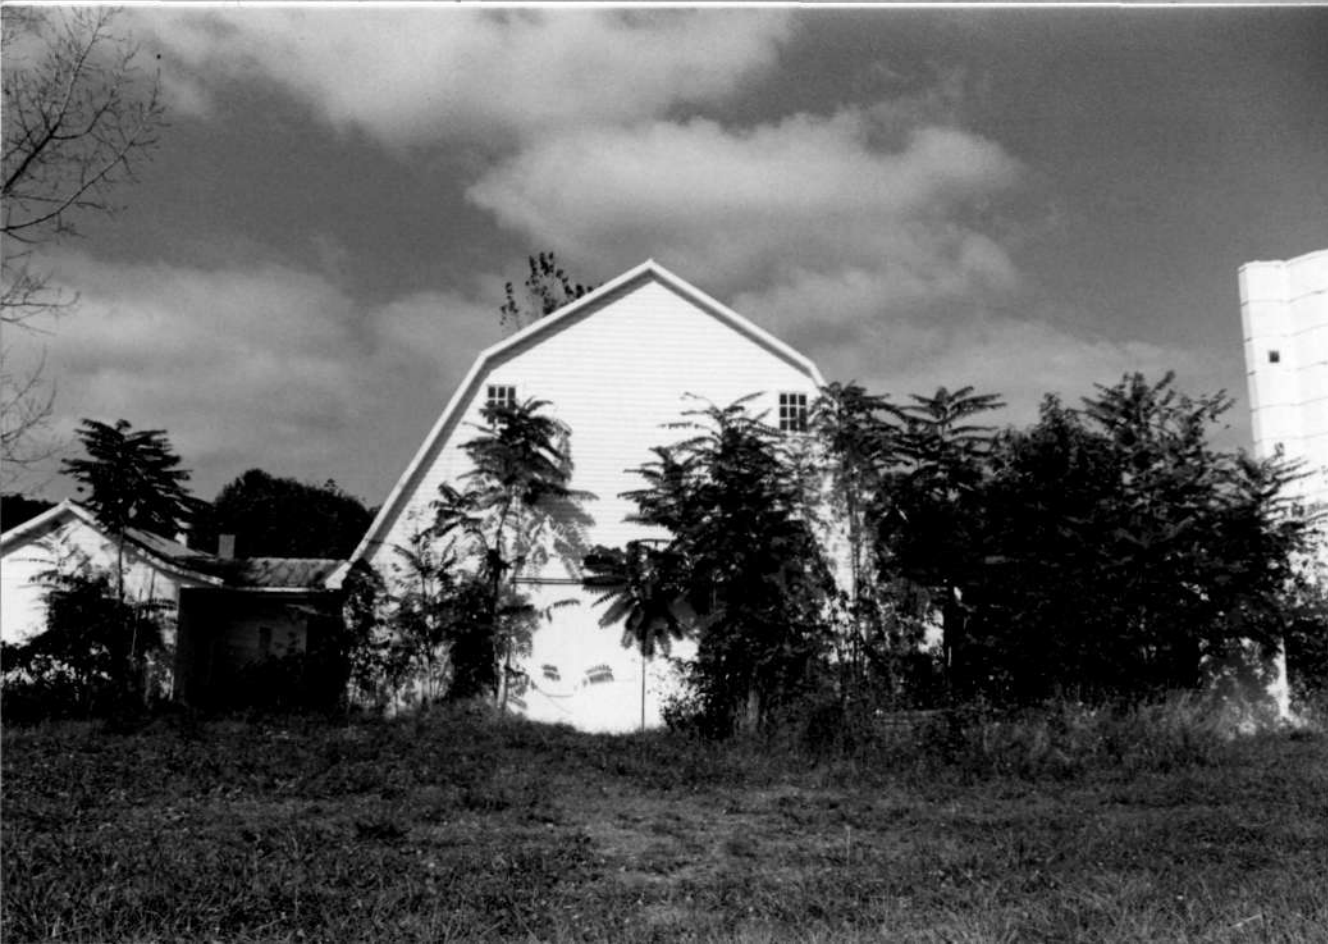
20
21

Dairy barn complex, view NW

Silo: The concrete silo is wrapped with steel straps. There is no cap. A block shed is directly attached to the silo. The silo/shed complex is connected to the dairy barn by a roofed, open-sided breezeway.
